# Your Inspection Report

41 Grandview Avenue  
Toronto, ON M4K 1J1

RE: Report No. 4189  
41 Grandview Avenue  
Toronto, ON  
M4K 1J1

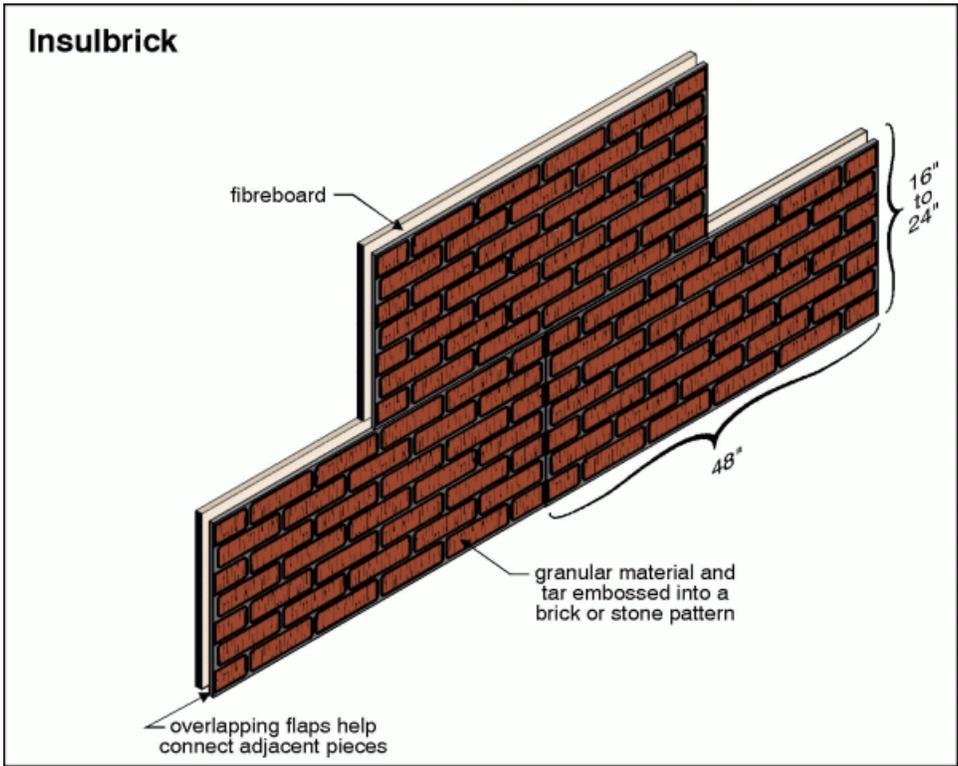
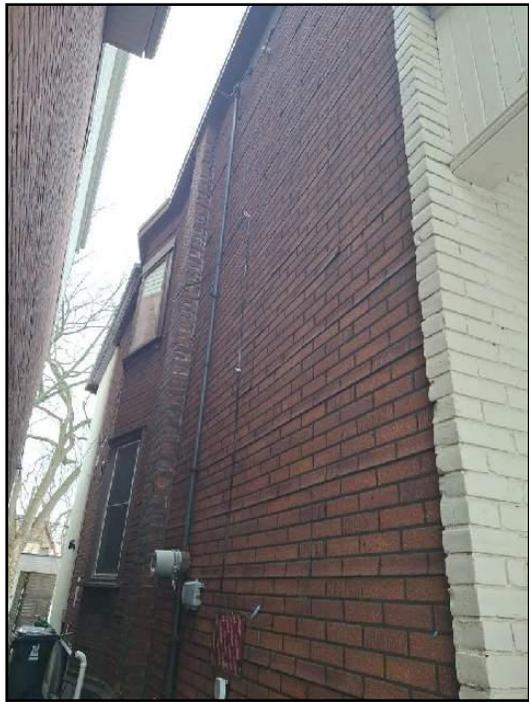
1.

**2. Condition:** • [Aging](#)

Insulbrick is old and will require eventual replacement.

**Implication(s):** Chance of water damage to structure, finishes and contents

**Location:** East Exterior Wall

**Task:** Replace

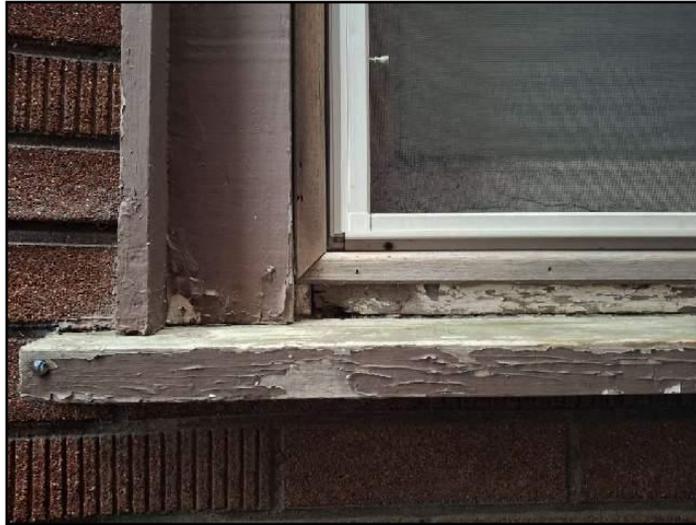
2.

3. Condition: • [Rot](#)

Some wood frame windows require restoration or replacement.

**Implication(s):** Chance of water damage to structure, finishes and contents | Material deterioration

**Location:** Various Exterior

**Task:** Repair or replace

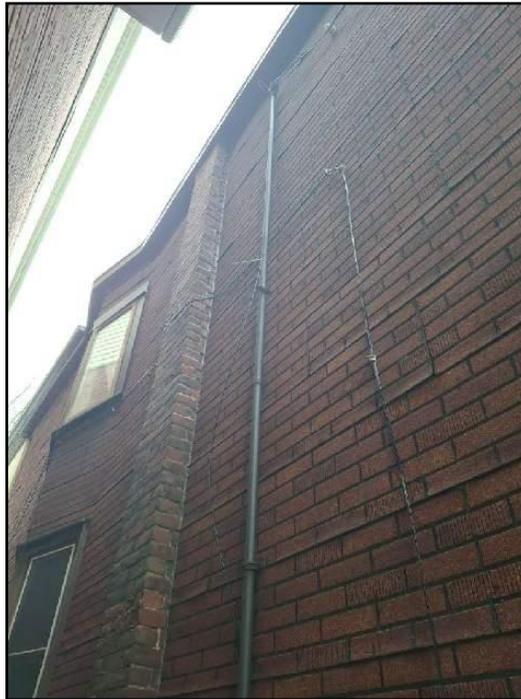
3.

**6. Condition:** • [Mast loose](#)

**Implication(s):** Electric shock | Interruption of electrical service

**Location:** Northeast Exterior Wall

**Task:** Repair

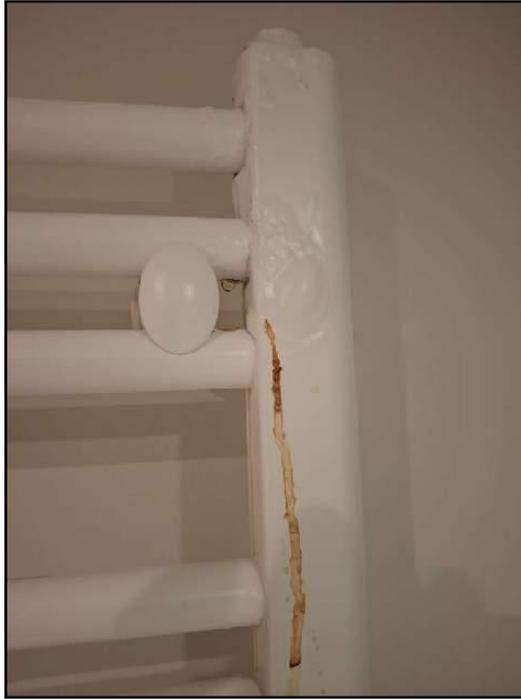
4.

**9. Condition:** • [Leak](#)

**Implication(s):** Chance of water damage to structure, finishes and contents

**Location:** Basement Bathroom

**Task:** Replace Rad

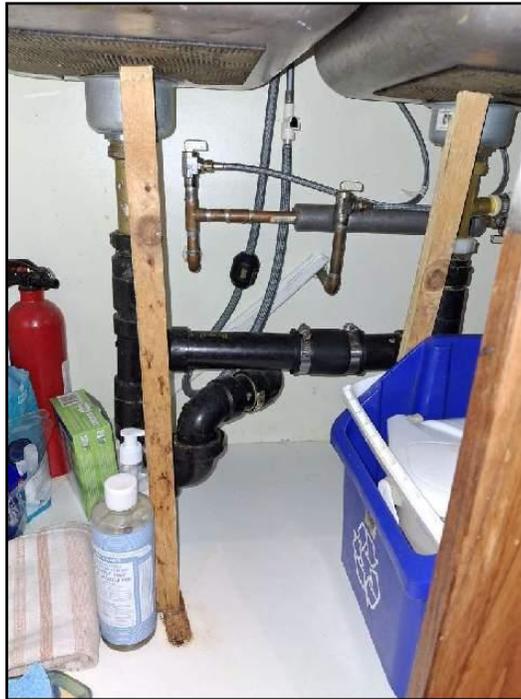
5.

**12. Condition:** • If sink is found to require support (intended to be epoxy glued to underside of counter), replace temporary supports with permanent type.

**Location:** First Floor Kitchen

**Task:** Improve
